Liberia Electricity Regulatory Commission

TOTOTA ELECTRIC CORPORATIVE DISTRIBUTION SERVICE AREA (TOTOTA, BONG COUNTY) INSPECTION REPORT

The Technical Regulations Directorate (TRD)

NOVEMBER 2025

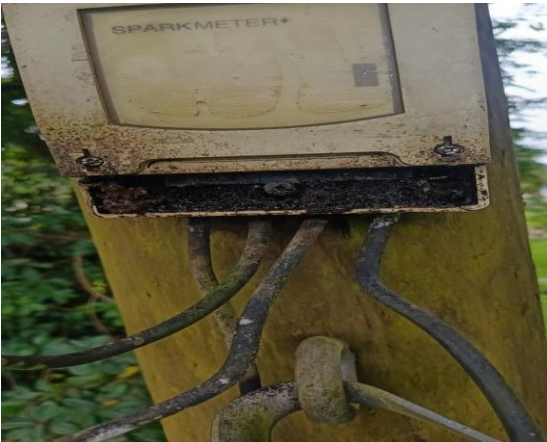
Metering Checklist			
6	Two damaged meters due to ants.	Mulbah Hill Community	Replace damaged meters and apply pest control measures.	Feb. 2026
	Safety Coordination			
7	Staff are not properly equipped with PPE.	TEC	Provide appropriate PPE to all staff.	December 2025
8	Environmental concern: Fuel spill observed on-site.	TEC power plant	Clean up the spill and implement environmental safeguards.	Nov. 2025
9	Permit-to-Work system not in place.	TEC	Establish and implement a Permit-to-Work system	Oct. 2025

Damaged Meters

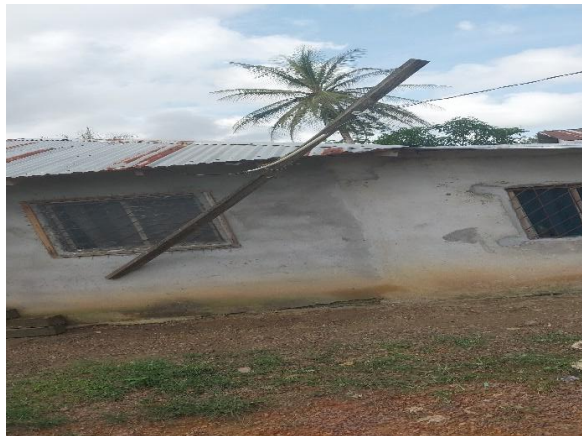
No.	Key Defects	Locations	Corrective Actions Required	Completion Dates
a	Documentation			
1	Some documents were provided to the Inspection Team for review.	Totota Electric Cooperative	LERC will work with TEC to develop templates for the documents submitted.	Feb. 2026
2	Lack of Annual Distribution Planning Report/Network Expansion Plan, System Study Report, and published weekly network performance on its website.	TEC	LERC will work with TEC to develop its network expansion plan and system study report.	April 2026
3	The logbook has not been used since April 2025.	TEC	Ensure the usage of log books.	October 2025
b	Low voltage (0.4/0.230kV) Network Checklist			
4	Bird nesting in meters.	Mulbah Hill Community and others.	Remove bird nests and implement preventive measures.	Oct. 2025
5	Service drops on sticks.	BRAC Office, Mulbah Hill Community.	Install proper utility poles for affected customers.	October 2025

Service Drop on Plank

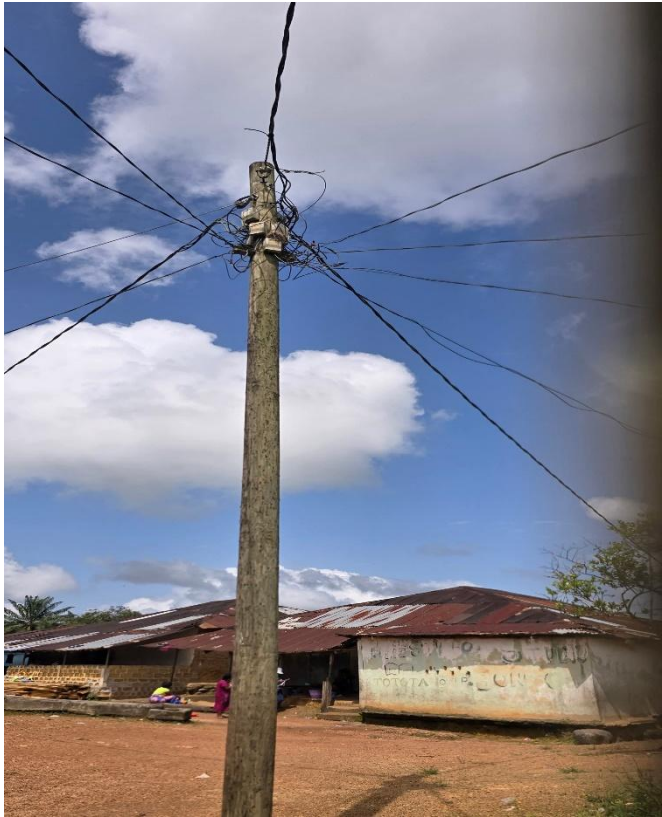
LV Pole
